**Flood Control Project Maintenance
Levee Inspections****LMA District Cover Sheet****Spring 2016 Levee Inspection Results****Sacramento River West Side Levee District**

Spring 2016 Levee Inspection Results

Sacramento River West Side Levee District

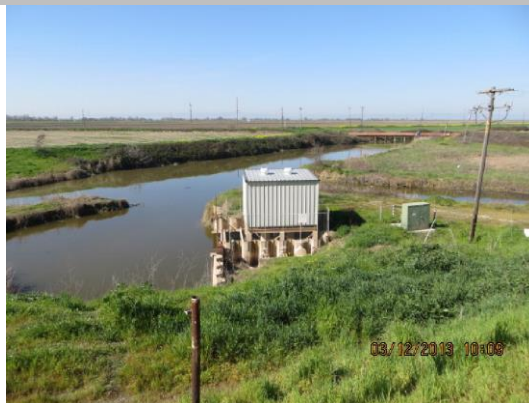
Photo 1 of 2 : UCIP_SP_2016_10087_17235.jpg

LM Start	0.14	Rating **	M	Issue No.	1568
LM End	0.14	Issue Type +	En	Location *	LS
Category	Supplemental			GPS Latitude/Longitude	
				Start	End
Item	DWR UCIP Field Study			38.801471 °	38.801471 °
				-121.725171 °	-121.725171 °
DWR ID					
Comment Code					
Inspector Comment					
FS_ID:10087					
DS_ID:20224					
EP_NO: N/A					
Repair Type: Non-Urgent					
Crossing Status: Found					
UCIP Comments: Headwall on WS undermined about 3-4-feet.					
FIELD_STRUCT_DESC: 1 of 3: 36-inch steel drainage pipe through					
levee 30.0 feet below crown. Flap gate on the waterward end. 24-inch					
pipe sleeved through the 36-inch pipe. Annular space between pipes					
grouted. Pumps in pumphouse with walkway on LS toe. Originally					
included in the 1960 O&M manual.					
FS Date: 3/12/2013

Pumphouse at LS toe.

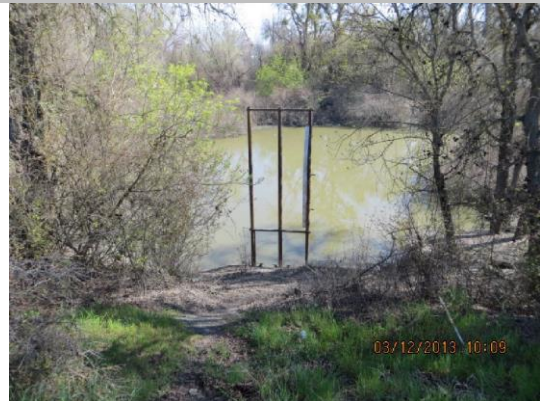
Photo 2 of 2 : UCIP_SP_2016_10087_17234.jpg

Air vents at outlet on WS toe.

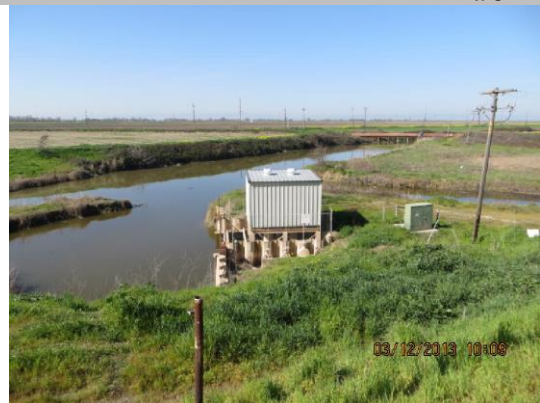
Photo 1 of 2 : UCIP_SP_2016_10085_17227.jpg

LM Start	0.14	Rating **	M	Issue No.	1567
LM End	0.14	Issue Type +	En	Location *	LS
Category	Supplemental			GPS Latitude/Longitude	
				Start	End
Item	DWR UCIP Field Study			38.801479 °	38.801479 °
				-121.725176 °	-121.725176 °
DWR ID					
Comment Code					
Inspector Comment					
FS_ID:10085					
DS_ID:20356					
EP_NO: N/A					
Repair Type: Non-Urgent					
Crossing Status: Found					
UCIP Comments: Headwall undermined 3-4-feet on WS toe.					
FIELD_STRUCT_DESC: 2 of 3: 36-inch steel drainage pipe through levee 30.0 feet below crown. Flap gate on the waterward end. 24-inch pipe sleeved through the 36-inch pipe. Annular space between pipes grouted. Pumps in pumphouse with walkway on LS toe. Originally included in the 1960 O&M manual.					
FS Date: 3/12/2013

Pump house on LS toe.

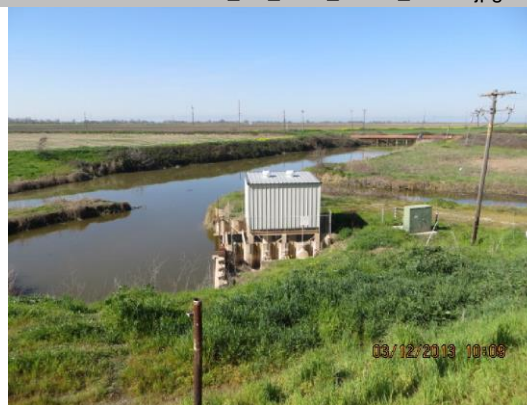
Photo 1 of 2 : UCIP_SP_2016_10910_18185.jpg

LM Start	0.14	Rating **	M	Issue No.	1566
LM End	0.14	Issue Type +	En	Location *	LS
Category	Supplemental			GPS Latitude/Longitude	
				Start	End
Item	DWR UCIP Field Study			38.801491 °	38.801491 °
				-121.725184 °	-121.725184 °
DWR ID					
Comment Code					
Inspector Comment					
FS_ID:10910					
DS_ID:20357					
EP_NO: N/A					
Repair Type: Non-Urgent					
Crossing Status: Found					
UCIP Comments: Headwall undermined 3-4-feet on WS toe.					
FIELD_STRUCT_DESC: 3 of 3: 36-inch steel drainage pipe through					
levee 30.0 feet below crown. Flap gate on the waterward end. 24-inch					
pipe sleeved through the 36-inch pipe. Annular space between pipes					
grouted. Pumps in pumphouse with walkway on LS toe. Originally					
included in the 1960 O&M manual.					
FS Date: 3/12/2013

Pumphouse on LS toe.

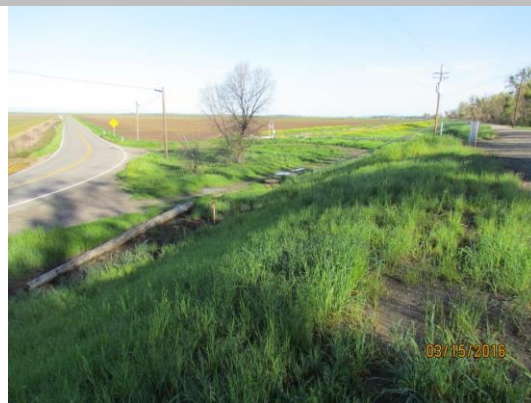
Photo 1 of 1 : SP_2016_NA0016_435_107_20160321_00193.jpg

A utility pole is at the toe of the levee on the landward side looking upstream. Spring 2016.

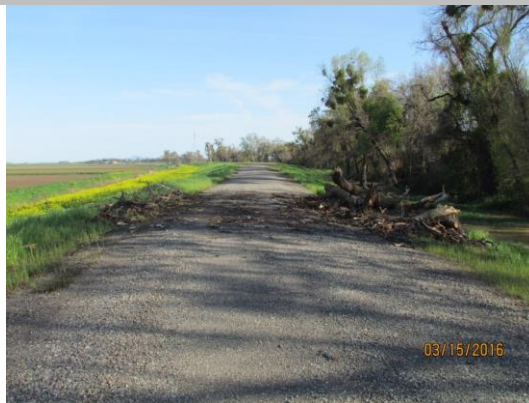
Photo 1 of 1 : SP_2016_NA0016_435_117_20160321_00195.jpg

View of tree limbs on the shoulder of the waterward side of the levee. Spring 2016.

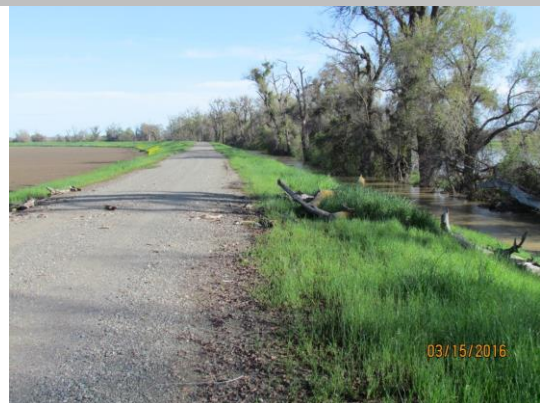
Photo 1 of 1 : SP_2016_NA0016_435_145_20160321_00198.jpg

View of the fallen tree on the waterward side of the levee looking upstream. Spring 2016.

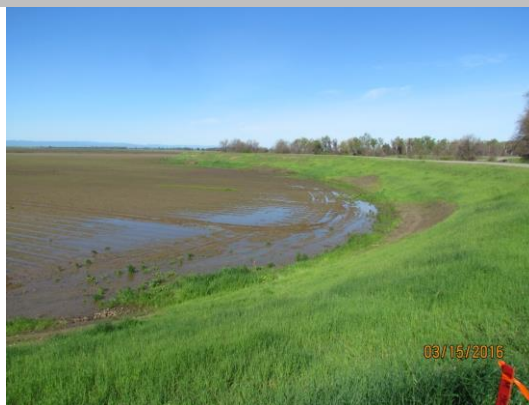
Photo 1 of 2 : SP_2016_NA0016_435_153_20160321_00205.jpg

LM Start	4.00	Rating **	U	Issue No.	153
LM End	4.15	Issue Type +	Ob	Location *	LS
Category	Earthen Levee			GPS Latitude/Longitude	
				Start	End
Item	Seepage / Sandboils			38.851382 °	38.851991 °
				-121.724708 °	-121.727000 °
DWR ID	DWR_NA0016_01_s_2016_153				
Comment Code					
Inspector Comment					
Seepage area has been staked and noted by LMA. Monitor seepage site.

View of the seepage on the landward side of the levee looking upstream. Spring 2016.

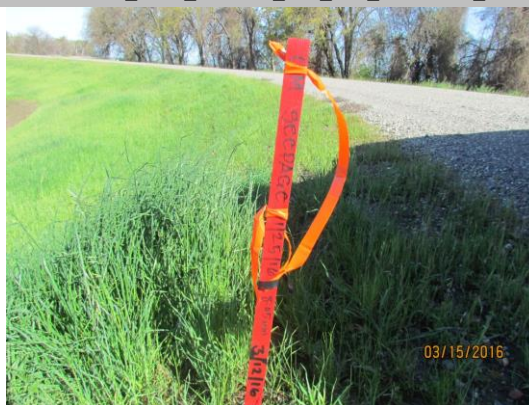
Photo 2 of 2 : SP_2016_NA0016_435_153_20160321_00206.jpg

LMA has staked seepage area and are monitoring the situation.

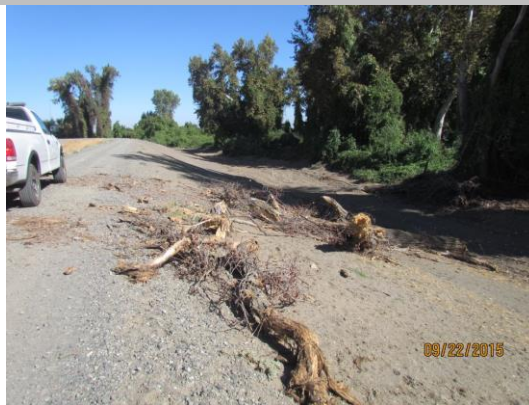
Photo 1 of 1 : SP_2016_NA0016_435_112_20160304_00057.jpg

View of the tree branches on the waterward side of the levee looking upstream. Fall 2015.

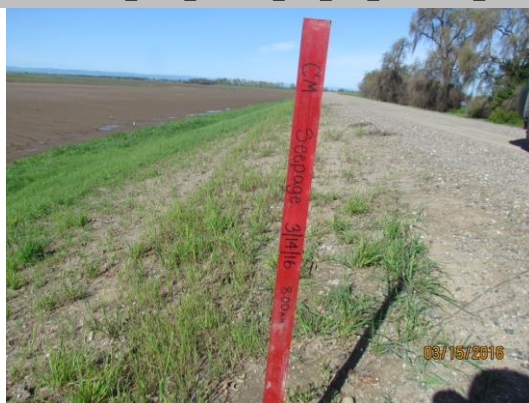
Photo 1 of 2 : SP_2016_NA0016_435_111_20160321_00208.jpg

LM Start	4.99	Rating **	U	Issue No.	111
LM End	5.09	Issue Type +	Ob	Location *	LS
Category	Earthen Levee			GPS Latitude/Longitude	
				Start	End
Item	Seepage / Sandboils			38.859909 °	38.860409 °
				-121.736119 °	-121.738001 °
DWR ID	DWR_NA0016_01_s _ 2016_111				
Comment Code					
Inspector Comment					
Seepage area has been staked and noted by LMA. Monitor seepage site.

Stake stating what date the seepage was last monitored. Spring 2016.

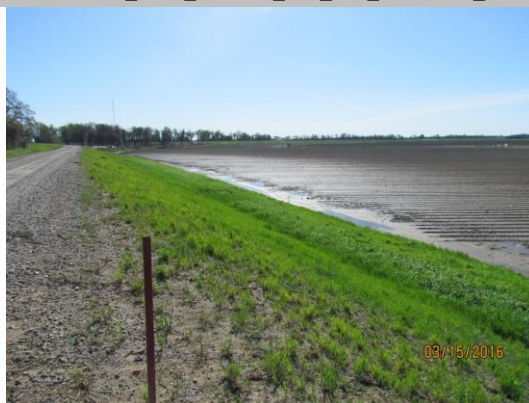
Photo 2 of 2 : SP_2016_NA0016_435_111_20160321_00209.jpg

View of the seepage on the landward side of the levee looking downstream. Spring 2016.

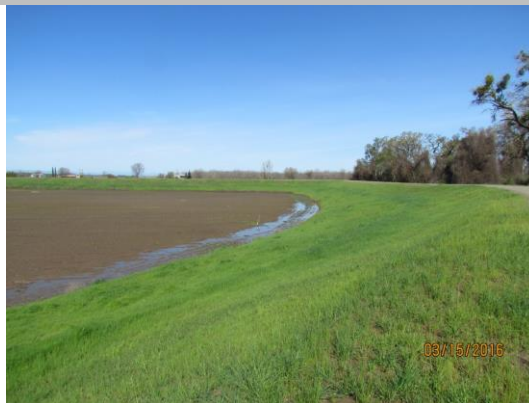
Photo 1 of 3 : SP_2016_NA0016_435_152_20160321_00210.jpg

LM Start	6.12	Rating **	U	Issue No.	152
LM End	6.12	Issue Type +	Ob	Location *	LS
Category	Earthen Levee			GPS Latitude/Longitude	
				Start	End
Item	Seepage / Sandboils			38.870503 °	38.870503 °
				-121.750068 °	-121.750068 °
DWR ID	DWR_NA0016_01_s_2016_152				
Comment Code					
Inspector Comment					
Seepage area has been staked and noted by LMA. Monitor seepage site.

View of the seepage on the landward side of the levee looking upstream. Spring 2016.

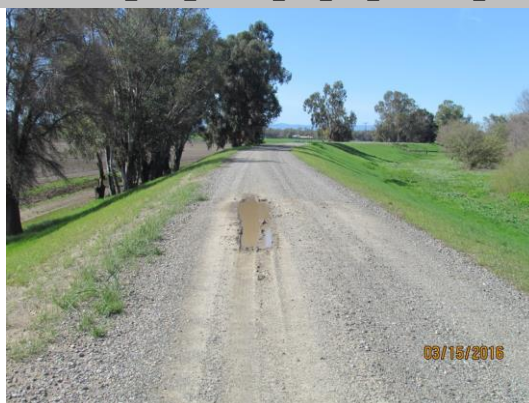
Photo 1 of 1 : SP_2016_NA0016_435_115_20160321_00217.jpg

View of the depression caused by vehicles on the crown of the levee looking upstream. Spring 2016.

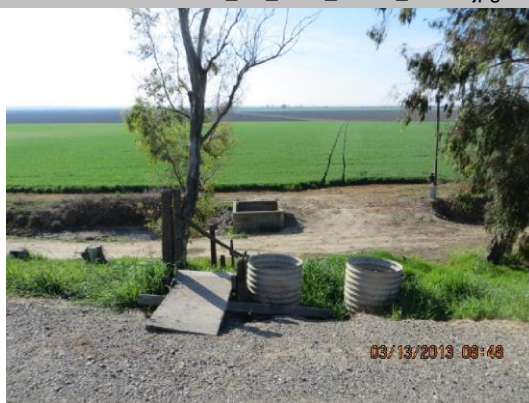
Photo 1 of 2 : UCIP_SP_2016_10144_17307.jpg

Stairs, distribution box, and air vent in CMP riser on LS.

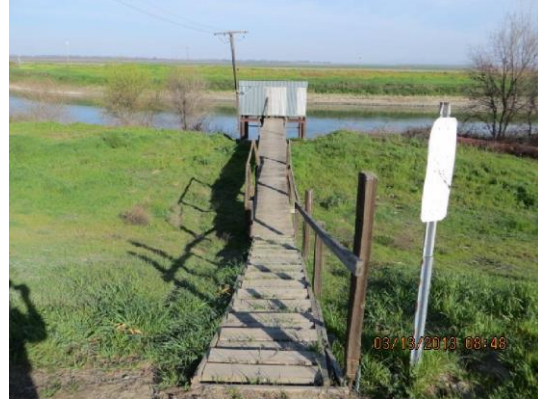
Photo 2 of 2 : UCIP_SP_2016_10144_17306.jpg

Stairs and pump on WS.

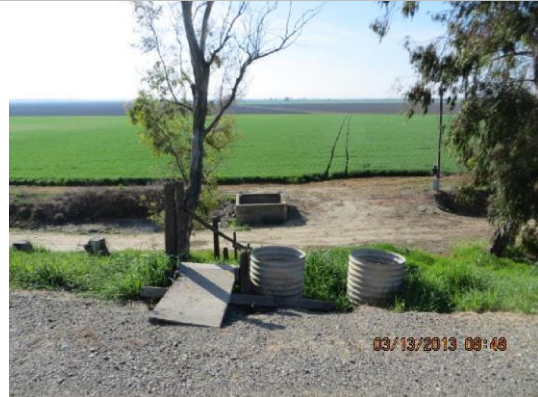
Photo 1 of 2 : UCIP_SP_2016_10143_17302.jpg

Steps, air vent in riser, and distribution box on LS.

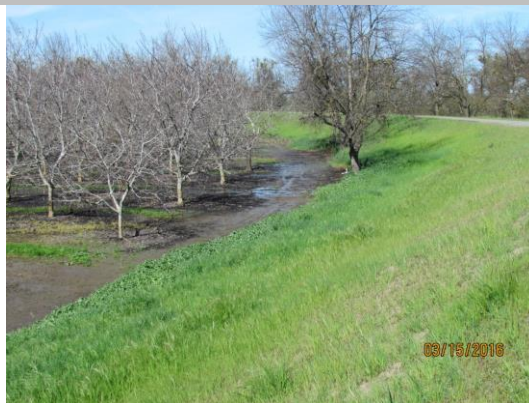
Photo 1 of 2 : SP_2016_NA0016_435_161_20160321_00222.jpg

View of the seepage on the landward side of the levee looking upstream. Spring 2016.

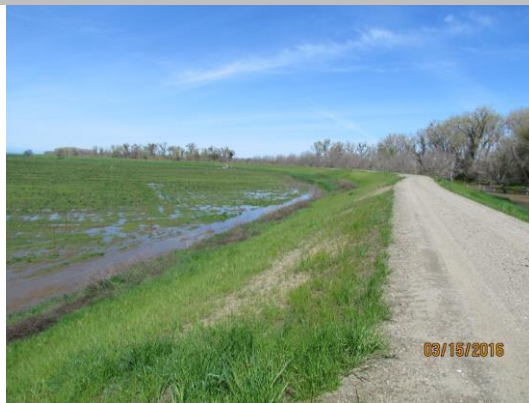
Photo 1 of 2 : SP_2016_NA0016_435_163_20160321_00225.jpg

View of the seepage on the landward side of the levee looking upstream. Spring 2016.

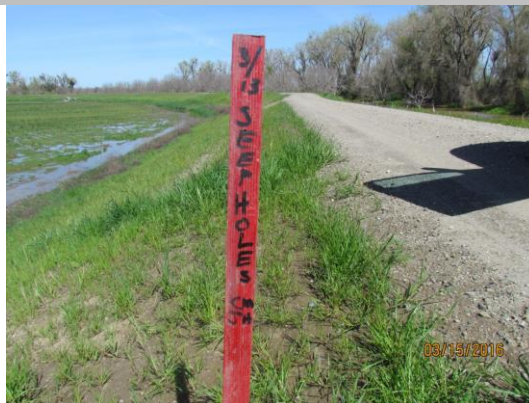
Photo 2 of 2 : SP_2016_NA0016_435_163_20160321_00223.jpg

Stake is planted on the shoulder of the levee on the landward side. Spring 2016.

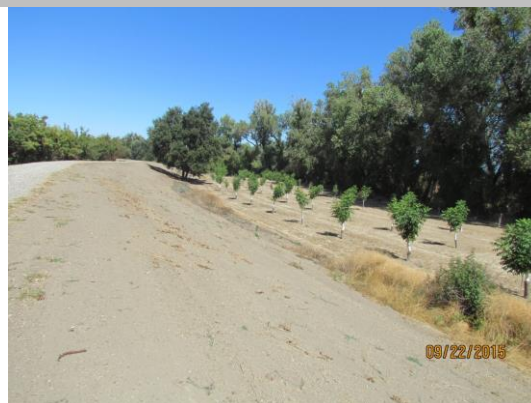
Photo 1 of 1 : SP_2016_NA0016_435_966_20160304_00081.jpg

View of the walnut orchard planted on the waterward side of the levee looking upstream. Fall 2015.

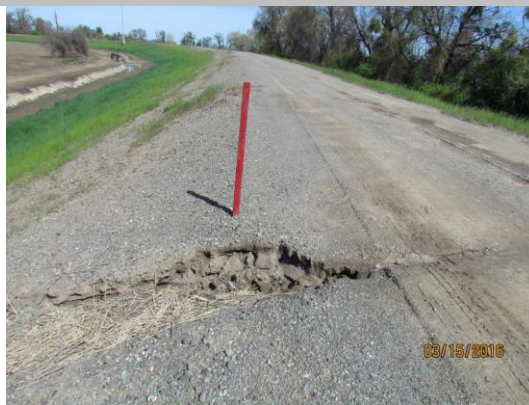
Photo 1 of 2 : SP_2016_NA0016_435_166_20160322_00231.jpg

View of the erosion on the landward shoulder of the levee looking upstream. Spring 2016.

Erosion is caused by runoffs. Spring 2016.

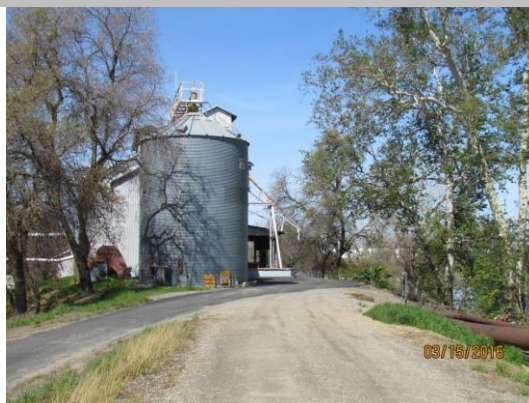
Photo 1 of 1 : SP_2016_NA0016_435_16_20160322_00240.jpg

View of the rice mill on the crown of the levee looking upstream. Spring 2016.

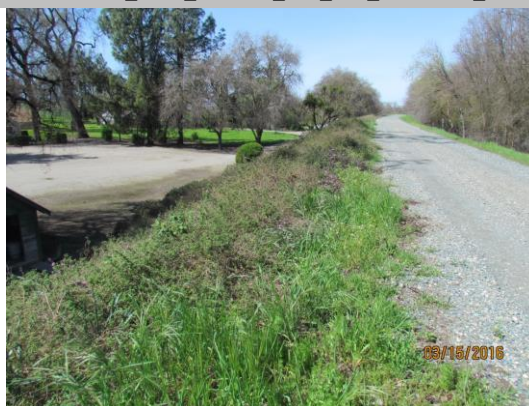
Photo 1 of 1 : SP_2016_NA0016_435_173_20160322_00241.jpg

View of the landscaping on the landward side of the levee looking upstream. Spring 2016.

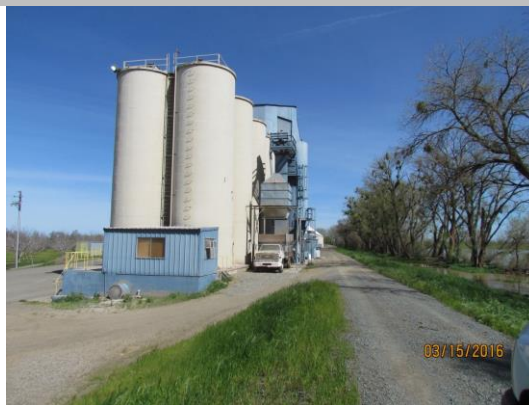
Photo 1 of 1 : SP_2016_NA0016_435_23_20160322_00242.jpg

View of the rice mill on the crown of the levee looking upstream. Spring 2016.

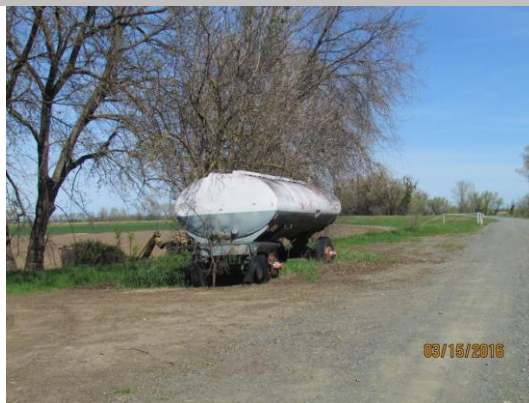
Photo 1 of 1 : SP_2016_NA0016_435_26_20160322_00244.jpg

View of the equipment on the crown of the levee looking upstream. Beehives have been removed. Spring 2016.

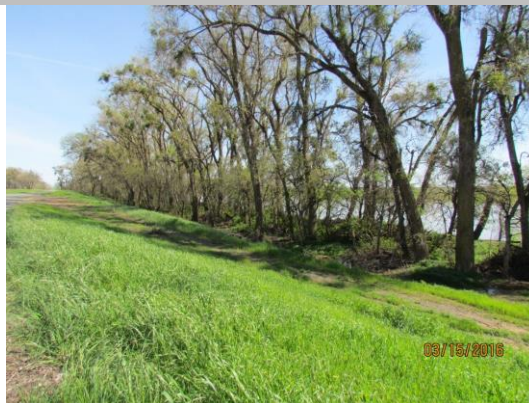
Photo 2 of 2 : SP_2016_NA0016_435_30_20160323_00251.jpg

View of the revegetation on the waterward berm of the levee looking upstream. Spring 2016.

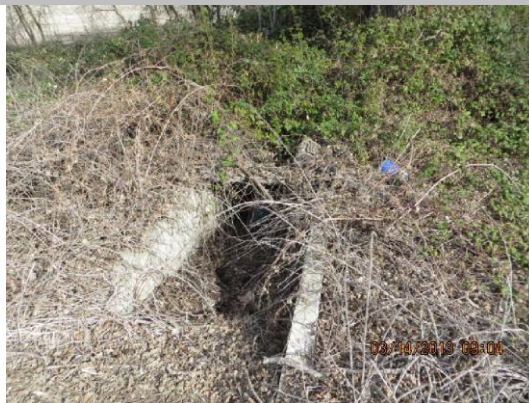
Photo 2 of 2 : UCIP_SP_2016_10266_17489.jpg

Concrete box on LS toe.

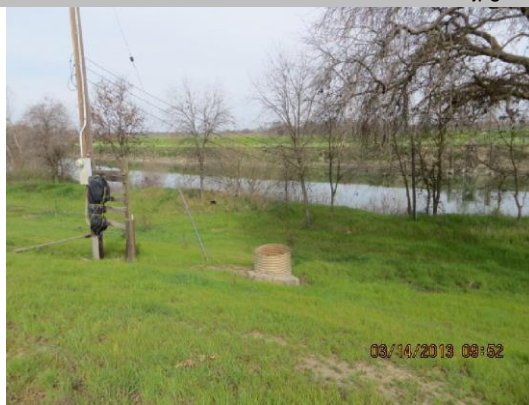
Photo 1 of 2 : UCIP_SP_2016_10265_17486.jpg

Slide gate in 36-inch CMP riser on WS slope.

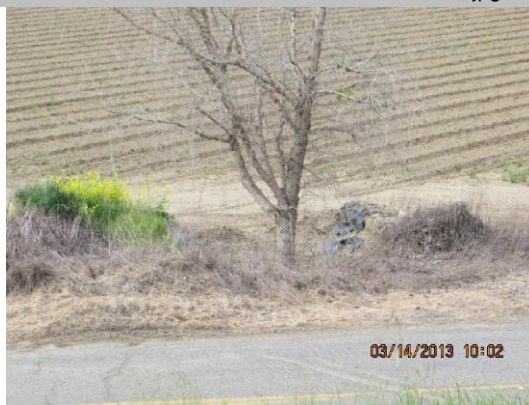
Photo 1 of 2 : UCIP_SP_2016_42860_17493.jpg

Pipe located at base of tree off LS toe.

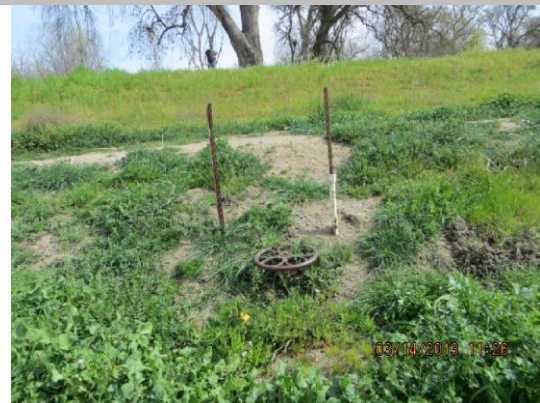
Photo 1 of 2 : UCIP_SP_2016_10289_17543.jpg

gate valve off landside toe.

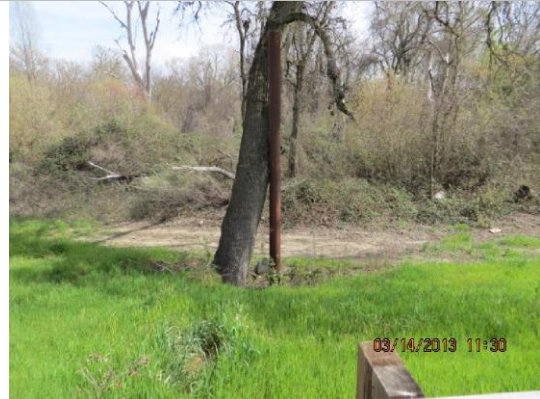
Photo 2 of 2 : UCIP_SP_2016_10289_17542.jpg

steel standpipe on WS toe.

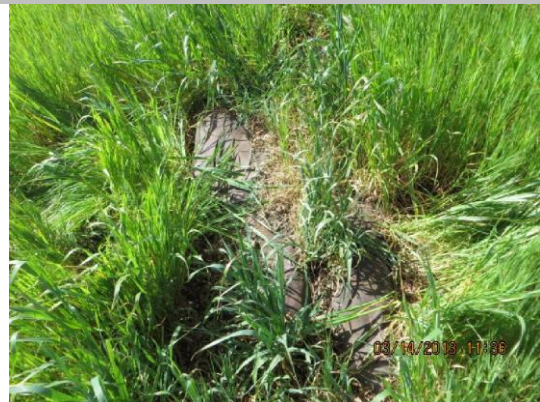
Photo 1 of 2 : UCIP_SP_2016_10290_17545.jpg

Pipe debris on WS slope.

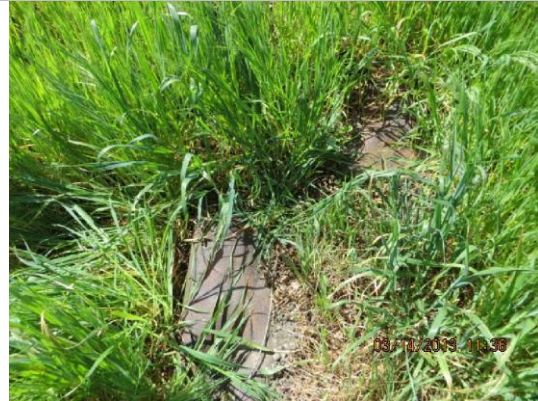
Photo 2 of 2 : UCIP_SP_2016_10290_17544.jpg

Pipe debris on WS slope.

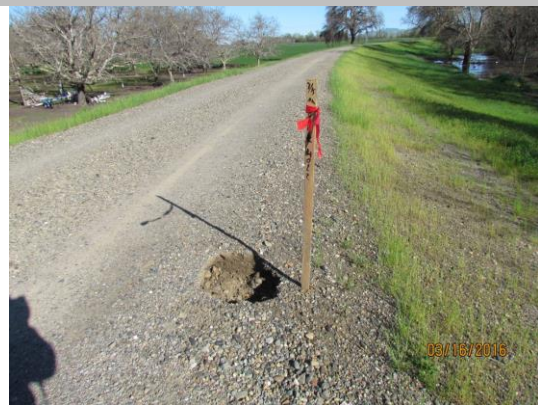
Photo 1 of 2 : SP_2016_NA0016_435_190_20160323_00254.jpg

View of the sink hole on the crown of the levee looking upstream. Spring 2016.

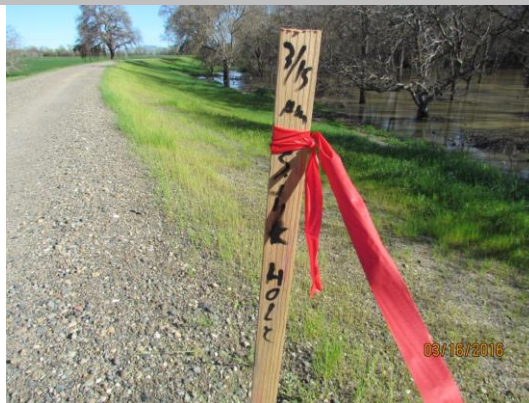
Photo 2 of 2 : SP_2016_NA0016_435_190_20160323_00255.jpg

Monitoring stake is placed next to the fox hole on the shoulder of the levee. Spring 2016.

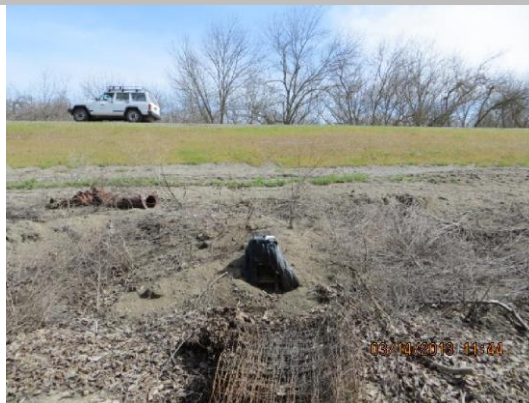
Photo 1 of 2 : UCIP_SP_2016_10291_17548.jpg

Gate valve buried on LS toe.

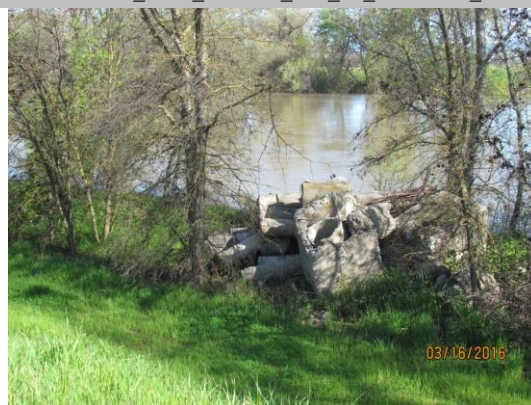
Photo 1 of 1 : SP_2016_NA0016_435_59_20160323_00256.jpg

View of the pile of concrete on the waterward berm of the levee. Spring 2016.

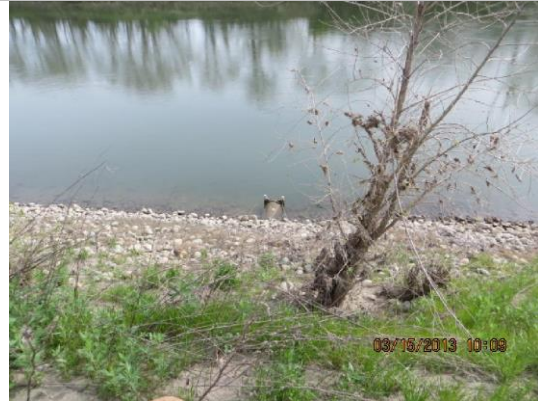
Photo 2 of 2 : UCIP_SP_2016_10324_17586.jpg

Pipe and flap gate at rivers edge

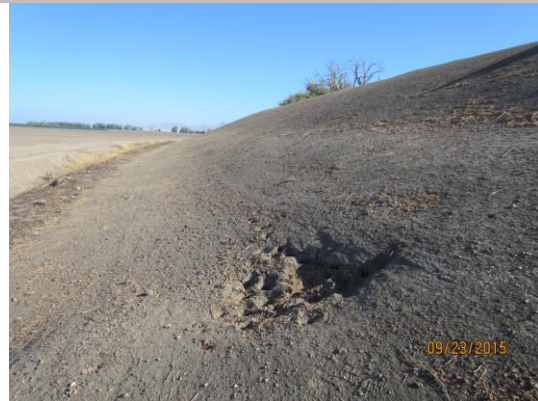
Photo 1 of 1 : SP_2016_NA0016_435_133_20160304_00070.jpg

View of the depression caused by animal activity on the landward side of the levee looking upstream. Fall 2015.

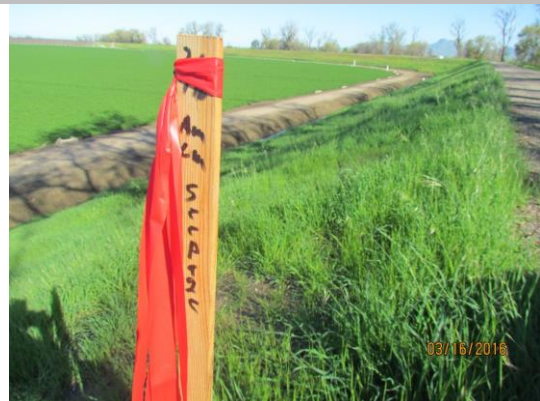
Photo 2 of 2 : SP_2016_NA0016_435_197_20160323_00259.jpg

Monitoring stake is on the waterward side of the levee. Spring 2016.

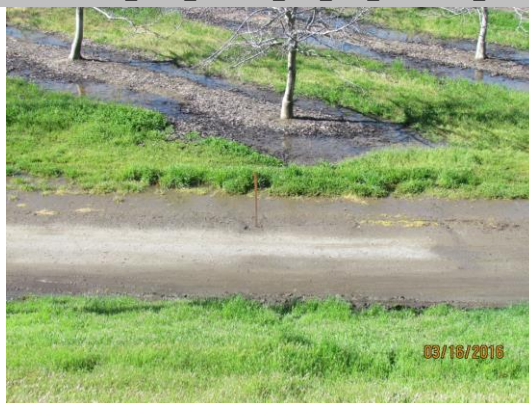
Photo 2 of 3 : SP_2016_NA0016_435_201_20160328_00266.jpg

Perspective view of the boil at the toe road on the landward side of the levee. Spring 2016.

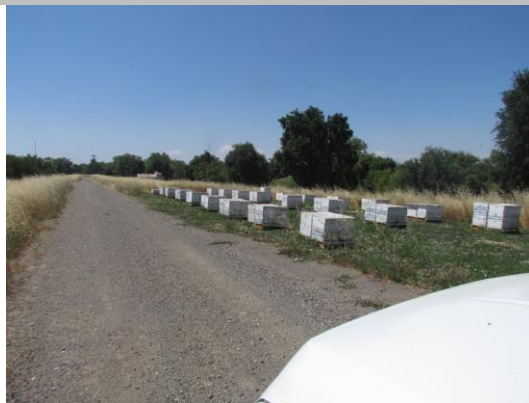
Photo 1 of 1 : SP_2016_NA0016_435_99_20160304_00051.jpg

View of the beehives on the shoulder of the waterward side of the levee looking upstream. Spring 2015.

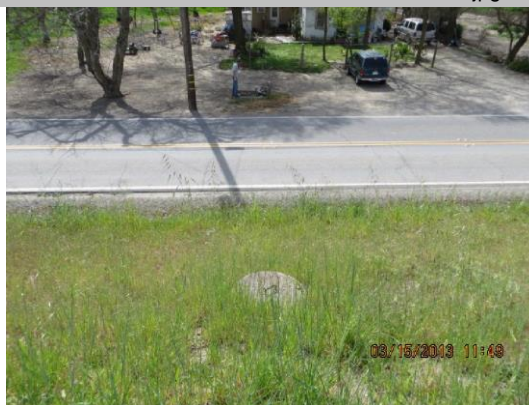
Photo 1 of 2 : UCIP_SP_2016_10364_17645.jpg

Siphon Breaker in 25-inch CMP riser on LS slope with 4X4 concrete box off LS toe.

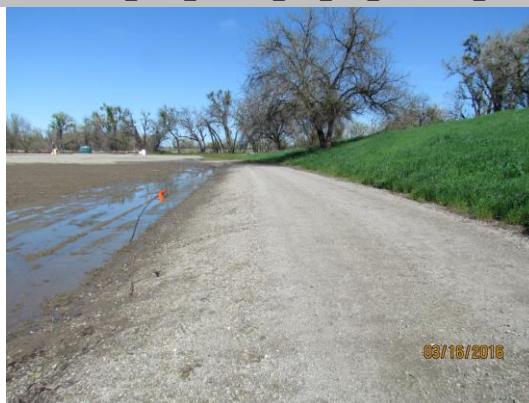
Photo 2 of 2 : SP_2016_NA0016_435_208_20160328_00271.jpg

View of the seepage and boil at the toe of the levee on the landward side looking upstream. Spring 2016.

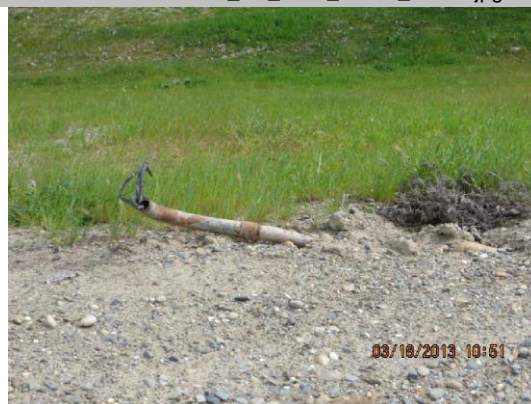
Photo 2 of 2 : UCIP_SP_2016_10425_17701.jpg

Electrical conduit on WS shoulder.

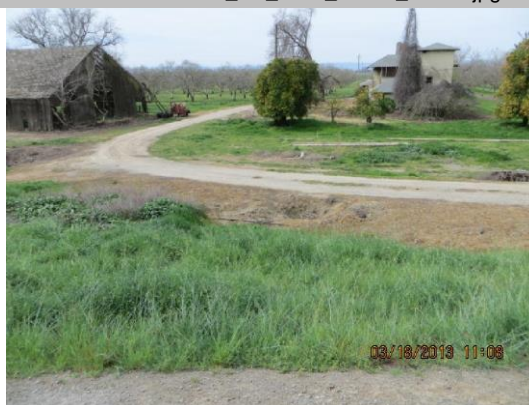
Photo 2 of 2 : UCIP_SP_2016_10426_17704.jpg

Headwall and gate valve on LS toe buried but partially exposed.

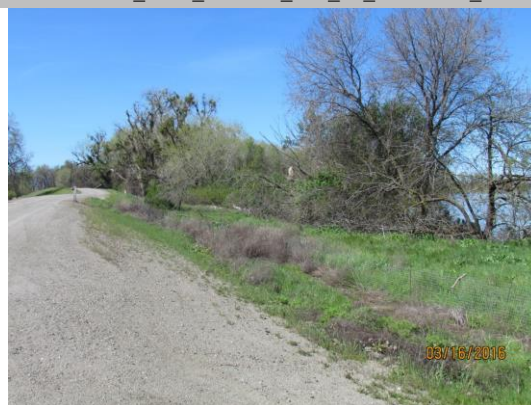
Photo 1 of 2 : SP_2016_NA0016_435_33_20160328_00276.jpg

View of the revegetation site on the waterward berm of the levee looking upstream. Spring 2016.

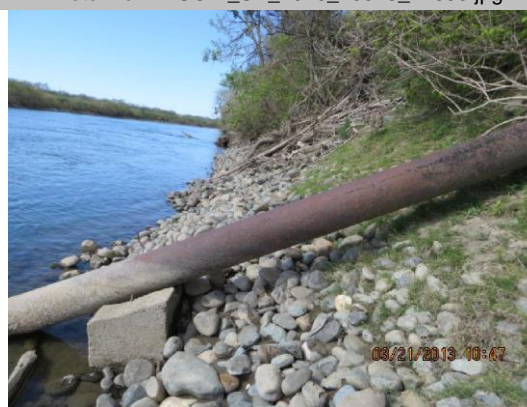
Photo 2 of 2 : UCIP_SP_2016_10528_17853.jpg

Pipe visible at WS toe.

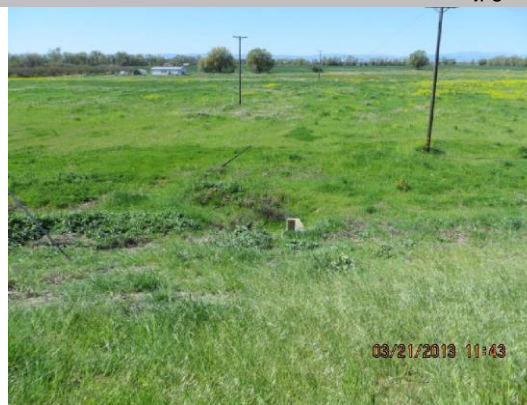
Photo 1 of 2 : UCIP_SP_2016_10533_17865.jpg

Demolished concrete distribution box at LS toe.

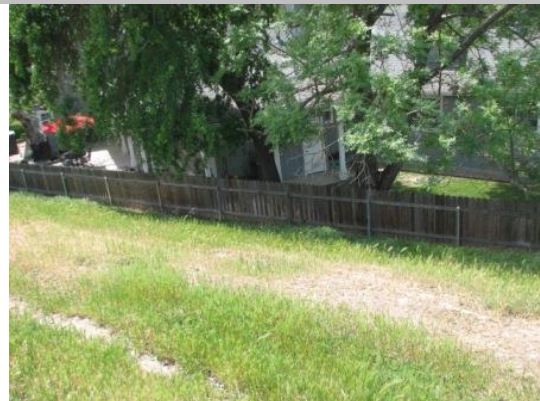
Photo 1 of 1 : SP_2016_NA0016_435_46_20160304_00030.jpg

A solid fence along the toe of the levee. Photo taken spring 2012.

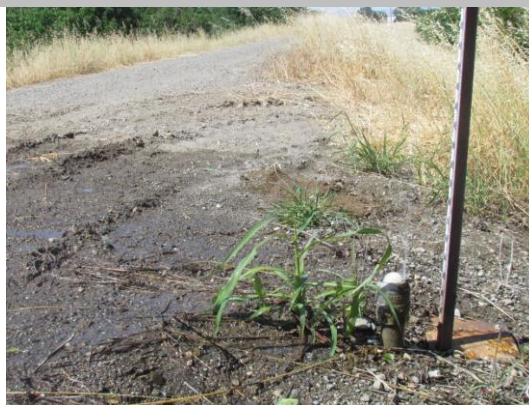
Photo 1 of 6 : SP_2016_NA0016_435_109_20160304_00054.jpg

View of the siphon breaker on the shoulder of the waterward side of the levee looking upstream. Spring 2015.

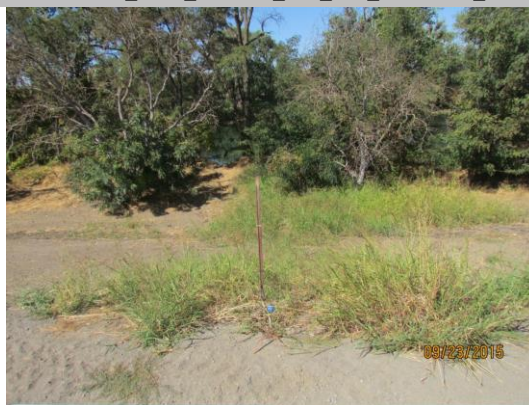
Photo 2 of 6 : SP_2016_NA0016_435_109_20160304_00055.jpg

Vegetation is aligned where the pipe is on the waterward side of the levee. Fall 2015.

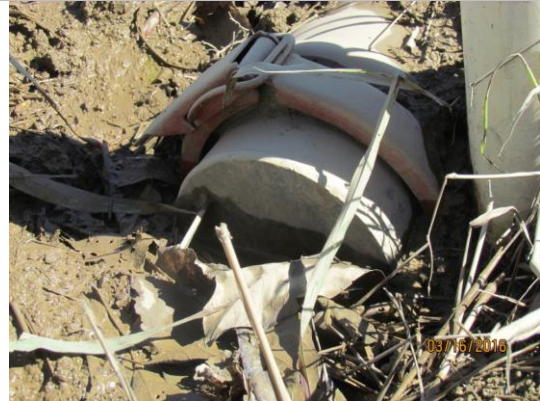
Photo 6 of 6 : SP_2016_NA0016_435_109_20160328_00292.jpg

Pipe seems to be capped off at the toe of the levee on the waterward side of the levee. Spring 2016.

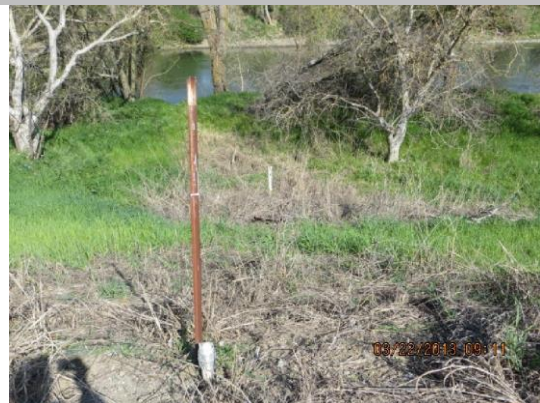
Photo 1 of 2 : UCIP_SP_2016_46812_17909.jpg

Broken fresno valve on WS shoulder

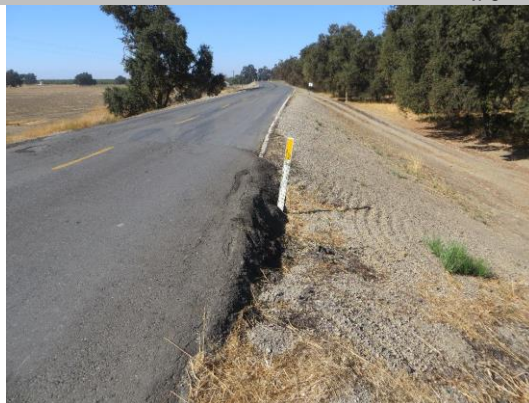
Photo 1 of 2 : UCIP_SP_2016_46773_74722.jpg

Recent pavement repair showing levee slumping. Photo taken from WS looking upstream along Moon Bend Rd

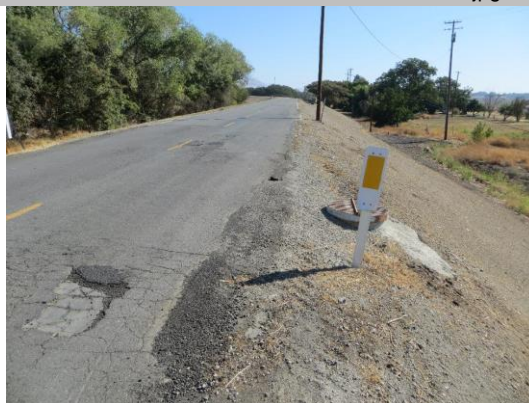
Photo 2 of 2 : UCIP_SP_2016_46773_74723.jpg

Siphon Breaker in 20-inch CMP riser on LS Shoulder. Photo taken from LS looking DS along Moon Bend Rd

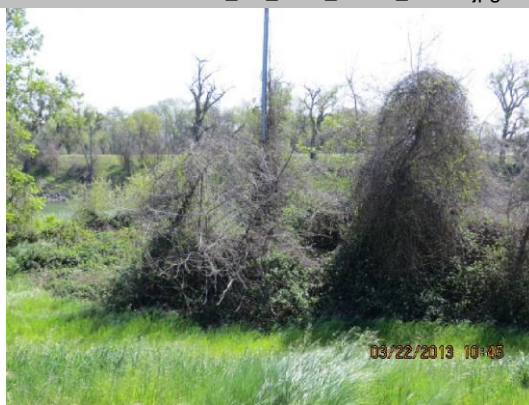
Photo 2 of 2 : UCIP_SP_2016_10566_17953.jpg

Pump covered in brush on WS berm.
